NIST NCSTAR 1-5A

**Federal Building and Fire Safety Investigation of
the World Trade Center Disaster**

Visual Evidence, Damage Estimates, And Timeline Analysis

William M. Pitts
Kathryn M. Butler
Valentine Junker

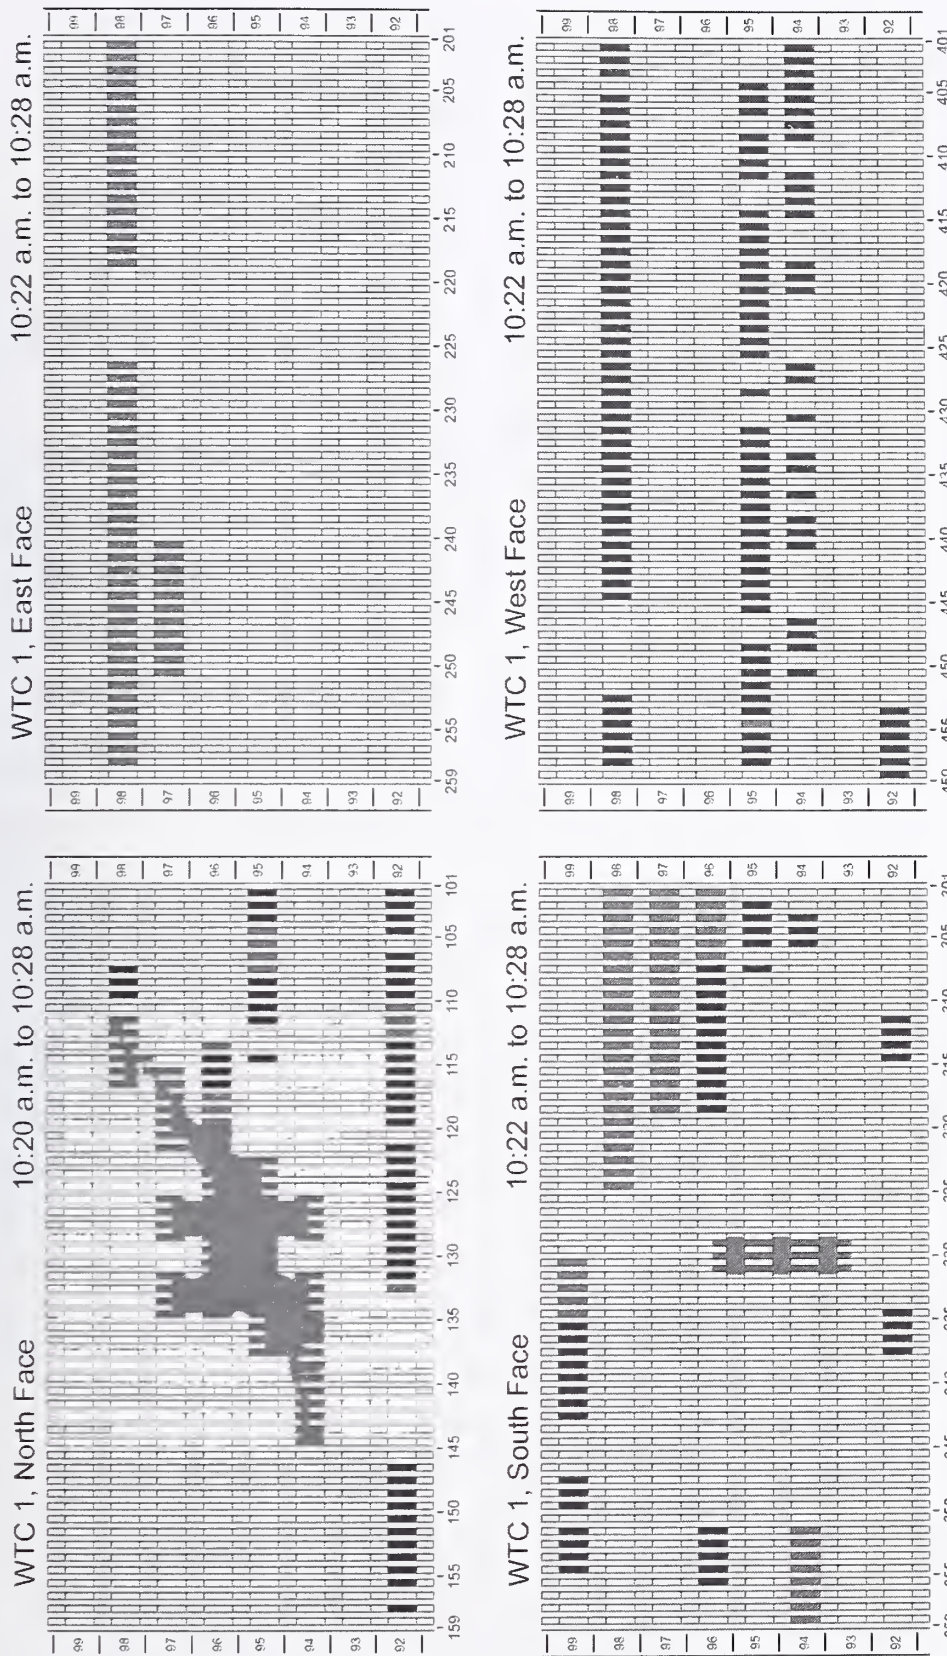
The results of integrating the fire data sheets for the period between 10:18 a.m. and 10:28 a.m. are shown in Figure 8-115. The same cautions apply as for the analogous data shown in Figure 8-93. In particular, data for the east and south faces should be considered approximate due to the quality of imagery for these faces during the period.

Comparison of Figure 8-93 and Figure 8-115 shows that during the final time period prior to the collapse of WTC 1, intense fires grew in or spread to several locations, including the western half of the north side of the 92nd floor, the southern half of the east side of the 98th floor, and the eastern halves of the south sides of the 98th and 99th floors.

On the east face a very intense flame developed on the south side of the 98th floor during the final ten minutes of the event. The external flames generated by this fire were some of the largest observed coming from WTC 1. It is likely that fires continued to burn on other floors on this side of the tower, but the imagery was not sufficient to create a complete record of these fires. There is evidence that a fire developed on this side of the 101st floor (not shown in figure).

During the final ten minutes before collapse very large fires were burning on multiple floors on the eastern side of the south face. This was the area that had been relatively isolated from fire during the first hour of the event. The fires on the 98th and 99th floors were particularly intense. The fire on the 99th floor appeared to have migrated from the west side of the face. The source of the 98th floor fire is more problematic since intense fires were observed earlier on this floor on the west side of the south face and at roughly the same time on the nearby east face. Whatever the source, the presence of extended regions of external flames on both the east and south faces shows that the fires in the southeast quadrant of the 98th floor were particularly intense during the period immediately prior to collapse.

Figure 8-115. Maps of integrated fire observations between 10:20 a.m. and 10:28 a.m. are shown for the four faces of WTC 1. Colors represent the highest intensity fire observed in a window using the color scale defined in Figure 5-1.

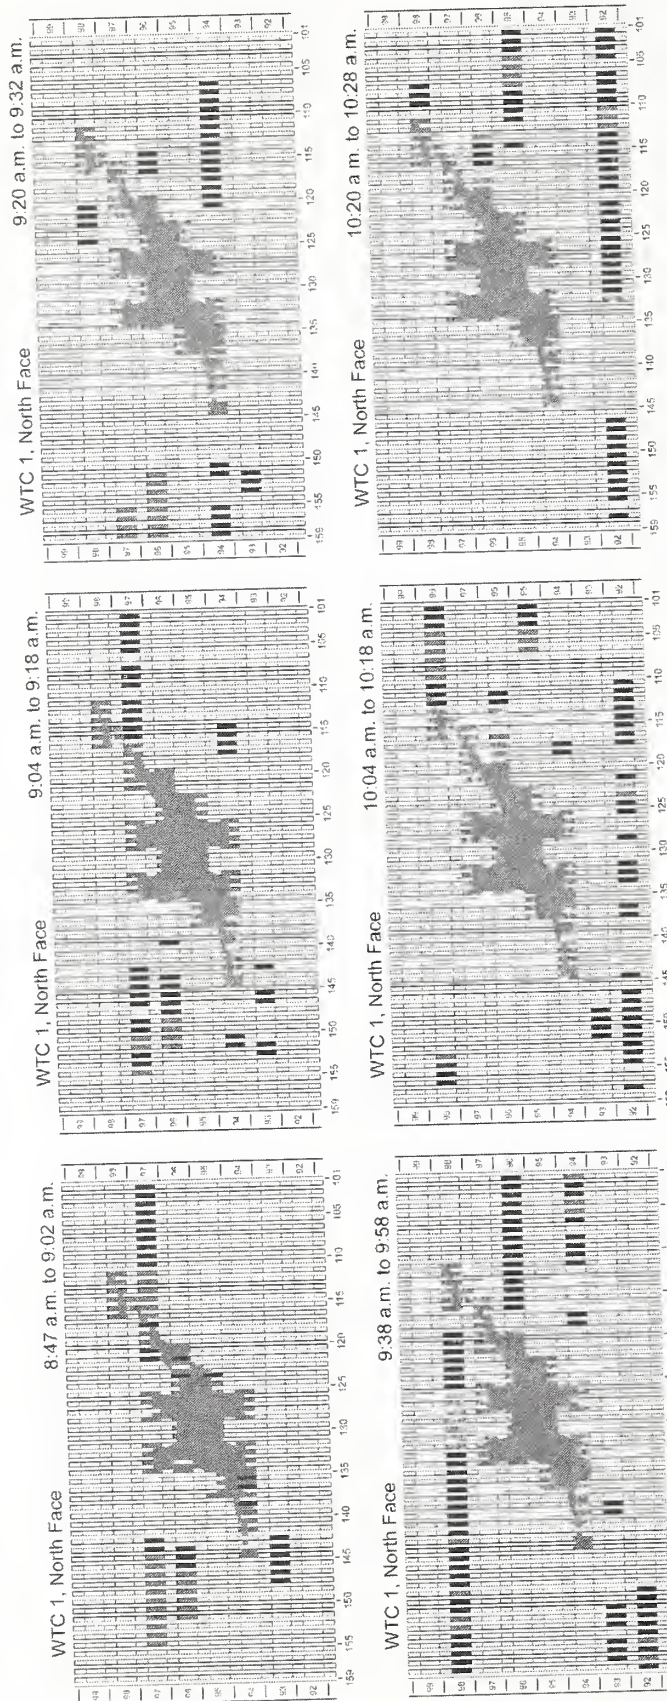
More than 5 min after the aircraft impact, growing fires suddenly appeared on the 97th floor at multiple façade locations that seemed to be initially undamaged (i.e., the window glass was intact) following the aircraft impact and fireballs. On the north face, an area to the east of the aircraft impact cavity, on the side opposite where the starboard fuel tank is suspected to have released aviation fuel, began to burn intensely. Shortly afterward, a fire appeared on the 97th floor on the west face and spread very rapidly to cover more than a third of the length of the face. This fire was intense, with flames extending from multiple windows. A second occurrence of rapid fire spread a few minutes later carried the fire even further to the south. Within ten minutes of the aircraft impact, a fire, which may have been present earlier, but hidden by smoke coming from lower floors; was identified on the 97th floor on the east face near windows 97-208 to 97-210. This fire quickly spread to cover at least 18 windows.

During this early phase, a fire also rapidly grew on the 96th floor on the north face to the east of the aircraft impact cavity. It is likely that this fire was also accelerated by aviation fuel dispersed into the area during the aircraft impact. Unlike for the 97th floor, fire growth and spread on the west side of the 96th floor was not apparent during this early period. A possible explanation for this observation is that most of the fuel that was released into this area from the aircraft's starboard fuel tank was either burned inside immediately or pushed out of the area by the overpressure generated by burning on this floor, subsequently forming the fireball observed on the south face and resulting in the damage observed on this floor. As a result, only limited amounts of liquid fuel likely remained to accelerate fire spread.

Figure 8-116. Maps of integrated fire intensity data for the north face of WTC 1 are plotted in sequence for the six time periods. Colors represent the highest intensity fire observed in a window using the color scale defined in Figure 5-1.

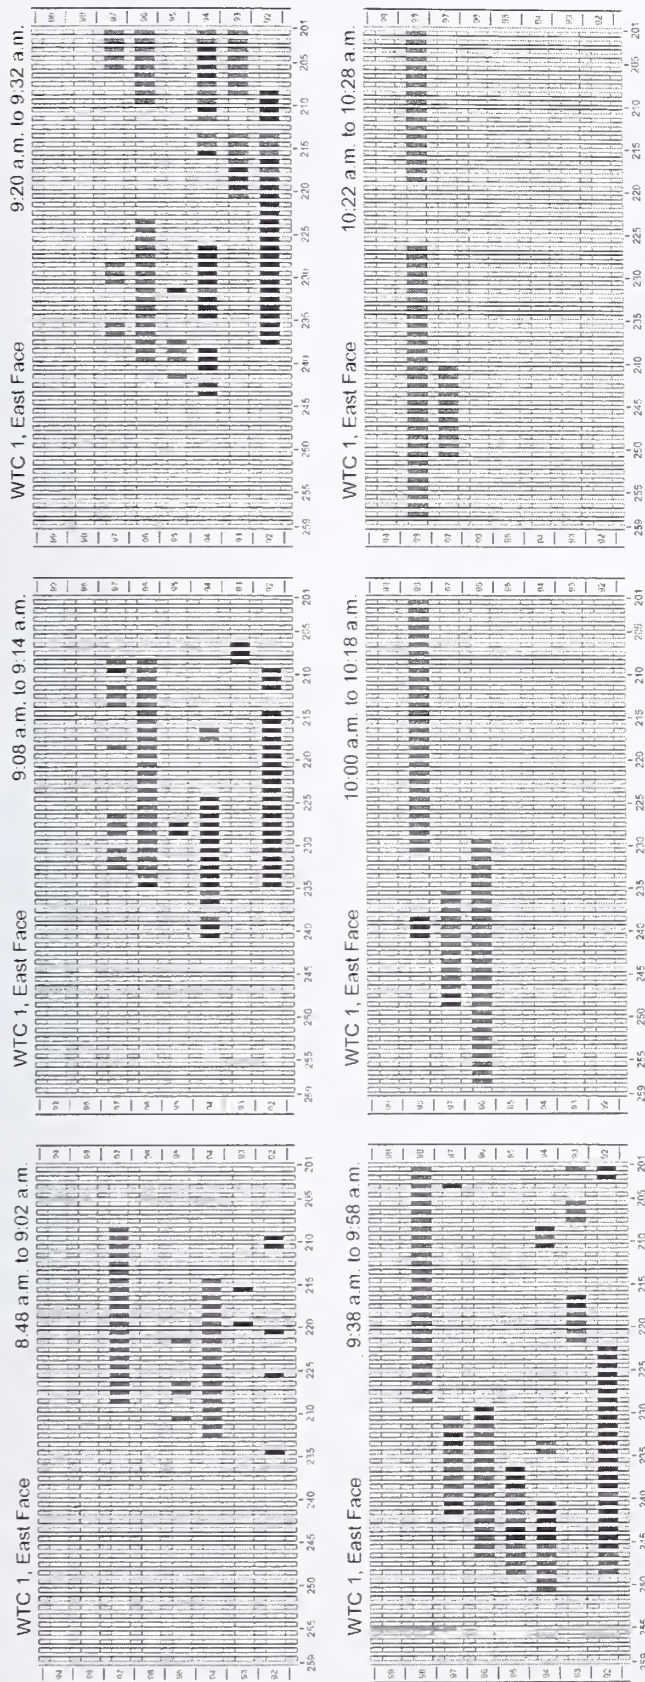
Figure 8-117. Maps of integrated fire intensity data for the east face of WTC 1 are plotted in sequence for the six time periods. Colors represent the highest intensity fire observed in a window using the color scale defined in Figure 5-1.

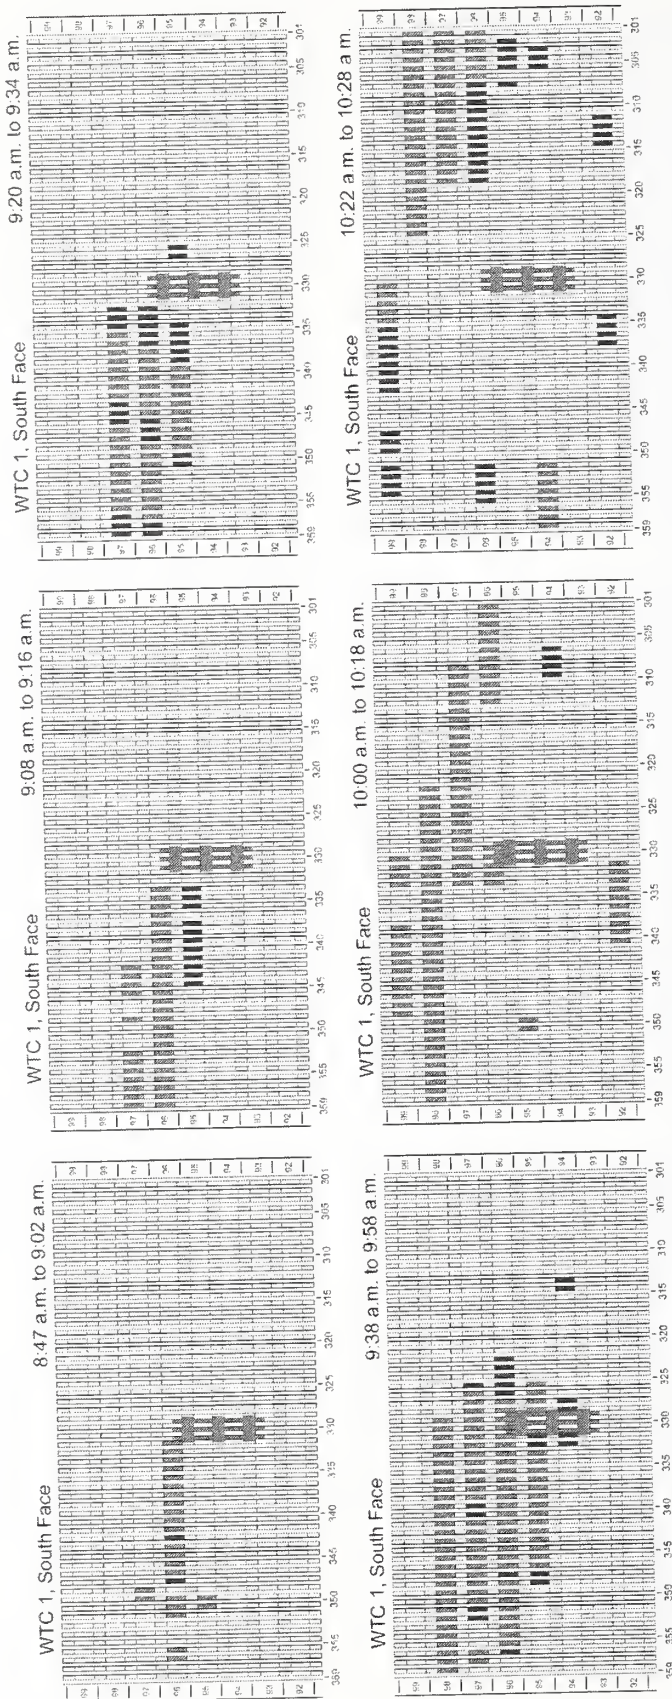
Figure 8-118. Maps of integrated fire intensity data for the south face of WTC 1 are plotted in sequence for the six time periods. Colors represent the highest intensity fire observed in a window using the color scale defined in Figure 5-1.

Fire growth and spread on the south face was extensive. The fire on the 96th floor spread to cover much of the western half of the floor and continued to burn intensely. New fires appeared on the western sides of the south face on the 95th and 97th floors and began to spread. Despite the intense fires burning on the western side of the face, there was, as yet, no indication of fire growth on the eastern side of the south face.

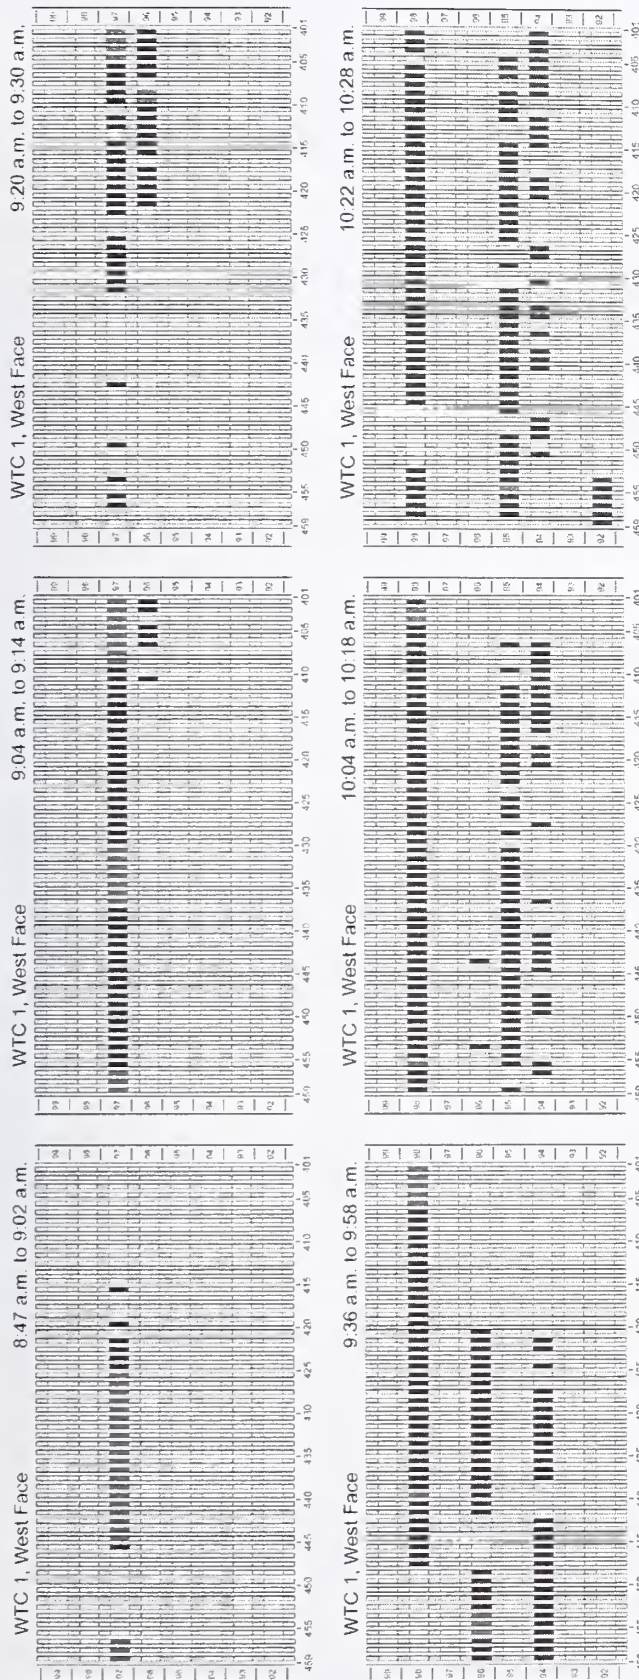
Figure 8-119. Maps of integrated fire intensity data for the west face of WTC 1 are plotted in sequence for the six time periods. Colors represent the highest intensity fire observed in a window using the color scale defined in Figure 5-1.

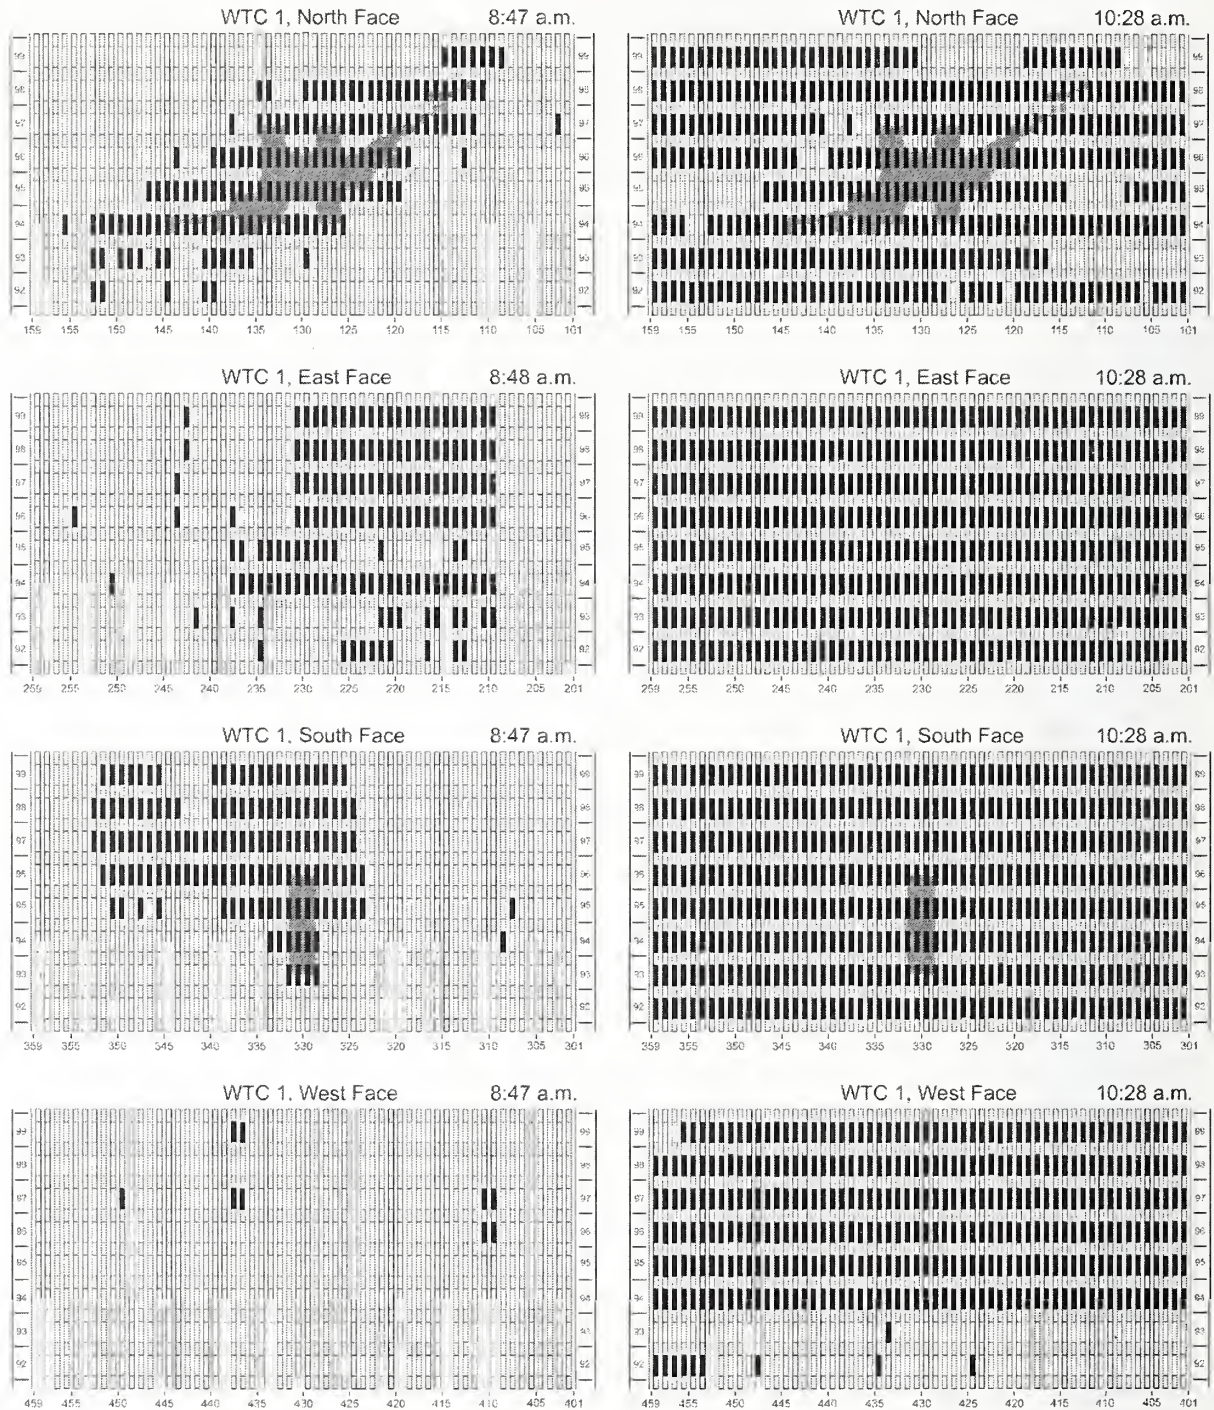
The information shown visually in Figure 8–120 is summarized numerically in Table 8–4 and Table 8–5. These two tables are similar to Table 8–2 and Table 8–3, which were generated using data from shortly after the aircraft impacted WTC 1 and just prior to the collapse of WTC 2. The results indicate that the total number of open windows on these floors increased by roughly 333 windows between 9:59 a.m. and 10:28 a.m. The increase in the number of open windows between the time from shortly after the aircraft struck WTC 1 and the collapse of the tower was approximately 1,048 windows, or a factor of 4.2. This corresponds to an increase in the open area on the façade available to provide air to the fires on these floors of around 12,190 ft².

Figure 8-120. Maps for the 92nd through the 99th floors compare missing windows for the four faces of WTC 1 at two times, immediately following the aircraft impact at 8:46:30 a.m. and just prior to the collapse of WTC 1 at 10:28:22 a.m.

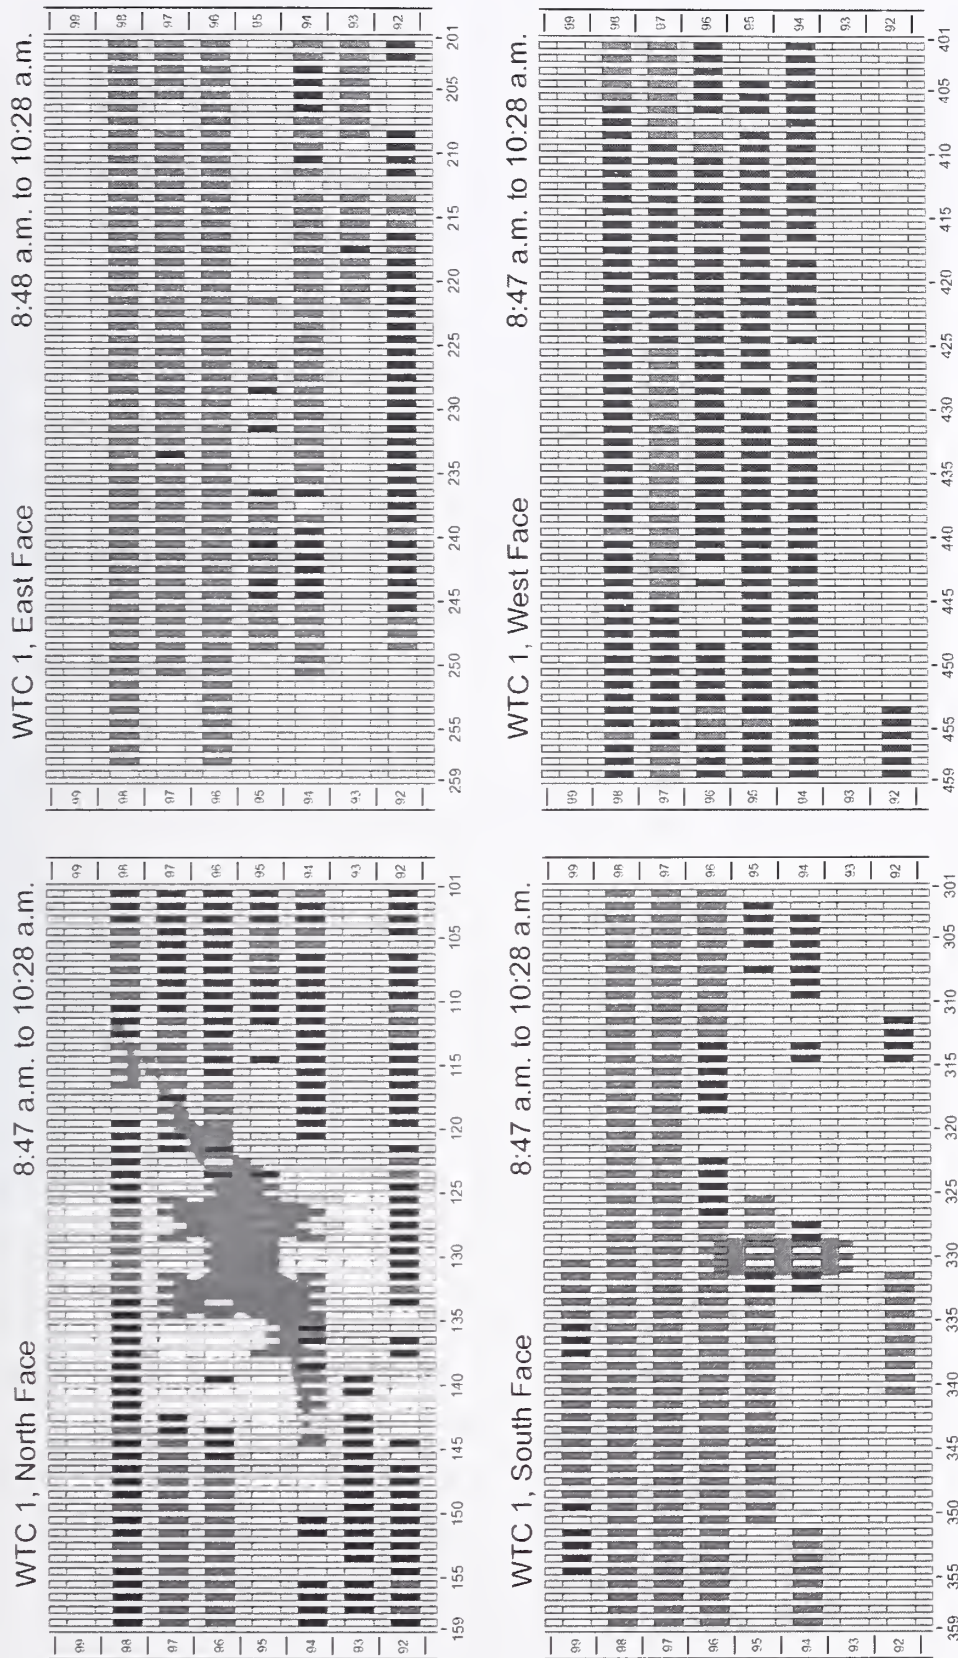
The results in the fire data sheets have been utilized to generate integrated fire data for the entire period between the aircraft impact and the collapse of WTC 1. The results are shown graphically in Figure 8–121 for the four faces of the tower. These maps demonstrate the extensive area of WTC 1 that was subjected to fire. Comparison with Figure 6–19, which shows the fire distribution on the four faces shortly after the aircraft impact, provides a graphic illustration of the amount of fire spread and growth that occurred. The relative numbers of windows in Figure 8–121 where external flames (orange) were observed compared to the total number of windows with observed fire reflects the differences between fire behaviors on the west and north faces as compared to the east and south faces, where external flaming was much more likely.

In contrast to the behavior on the west and north faces, fires burning on the east and south faces often generated heavy amounts of smoke and external flaming at nearby windows. It was common to observe many adjacent open windows with long extended flames. The tops of nearby column covers were often marked with carets. Examples of such fires were observed on the 94th, 96th, 97th, and 98th floors on the east face and on the 95th, 96th, 97th, 98th, and 99th floors on the south face. Exceptions to the general behavior included fires that developed on the 92nd floor on the east face and fires burning on the east side of the south face on the 92nd and 94th floors.

Various explanations for the different fire behaviors were considered. The most plausible is based on the effects of the prevailing wind. On September 11, 2001 the wind was striking WTC 1 from the northwest and then flowing down the north and west faces. This wind created positive pressures at the windows on these faces that tended to resist gas flows out of the tower. On the east and south faces the effect of the wind was the opposite, creating low pressure areas at the windows that tended to pull gases out of the building. The net effect of these pressure forces would be a tendency for gases to flow internally on a floor, if a pathway was available, from the west and north faces to the east and south faces. Such internal flows provide a possible explanation for the observed fire behaviors.

Figure 8-121. Maps of integrated fire observations between 8:47 a.m. and 10:28 a.m. are shown for the four faces of WTC 1. Colors represent the highest intensity fire observed in a window using the color scale defined in Figure 5-1.
